A hypothesis: could portable natural grass be a risk factor for knee injuries?

John Orchard ¹, Gil Rodas ², Lluis Til ², Jordi Ardevòl ² and Ian Chivers ³

Abstract

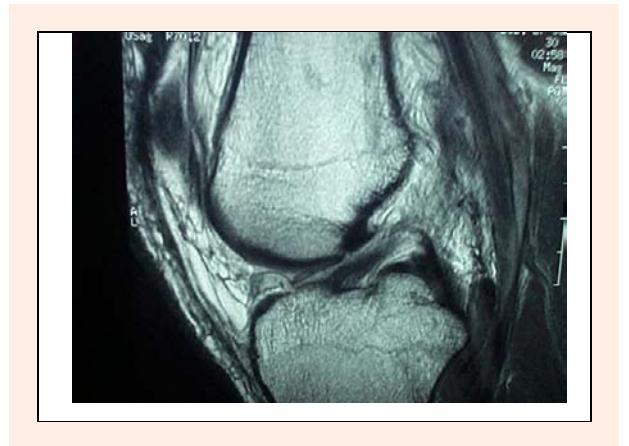
Figure 1. MRI scan of ruptured ACL in case 4.

Diagnosis: Right knee anterior cruciate ligament rupture plus small lateral meniscal tear (Figure 1).

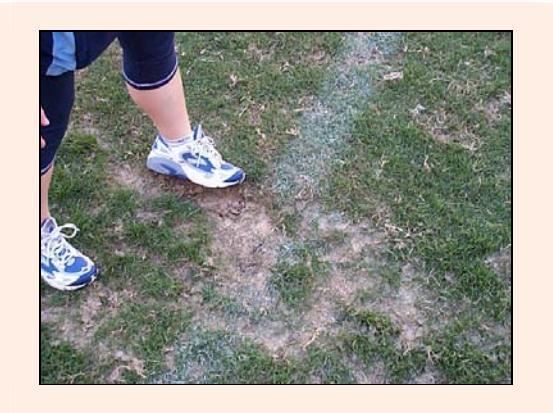
The playing surface at Suncorp Stadium, when first laid, was unusual and atypical (Figure 2). The playing surface was made up of turfgrass brought in on portable squares. These squares when laid down were apparently of inconsistent height after laying and therefore on the playing surface there were originally ridges of greater than 1cm height between the demarcations of the laid squares. Due to inadequate time after the laying of these squares to flatten the surface out, construction staff apparently decided to heavily topdress the ground with sand in order to flatten to playing surface.

Figure 2. The sandy surface at Suncorp stadium a month after it opened in June 2003.

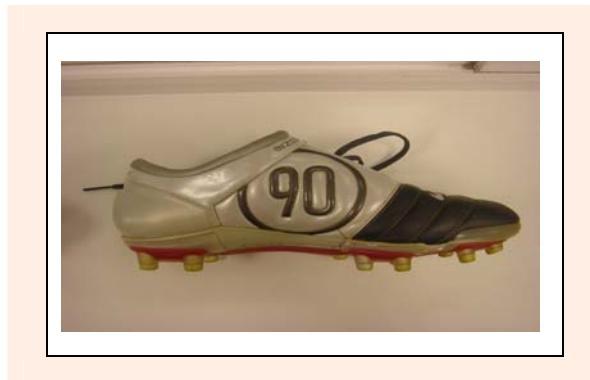
Figure 3. Boots worn by player in case 5.

Player details: Age 23yr, height 1.88m, weight 83kg. Boots used: Moulded sole (Figure 3).

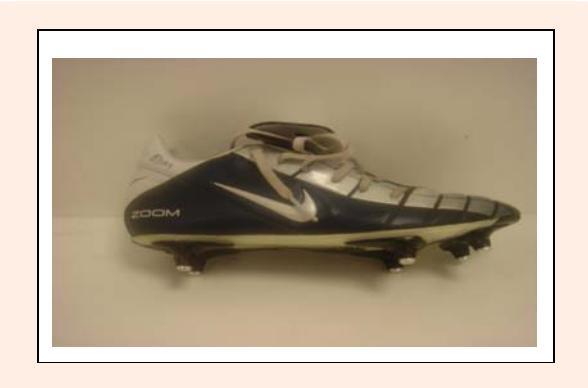
Figure 5. Boots worn by player in case 7.

Player details: Age 28yr, height 1.85m, weight 78kg. Boots used: Screw-in (Figure 5).

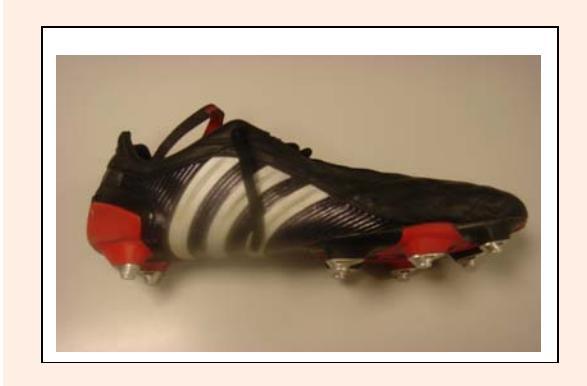
Figure 6. Boots worn by player in case 8

Player details: Age 34yr, height 1.78m, weight 74kg. Boots used: Screw-in (Figure 6).

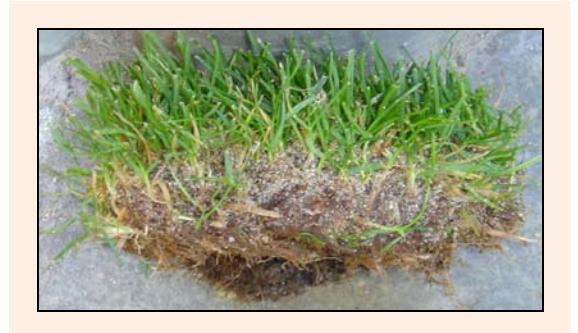
In October 2004 (after the third injury in this cluster) the IBV (Valencia biomechanics institute), a centre accredited for FIFA and UEFA, was called upon to analyse the grass parameters of the Camp Nou main field (Figures 7 and 8) compared to the training field (Gamez et al., 2004). In comparison with the training field (La Masia) the Campn Nou grass had greater hardness, measured as less impact absorption (42% compared to 53%, p < 0.001) and higher rotational traction (48 Nm compared to 39 Nm, p < 0.001). As traction values tend to fall over the course of the playing season (Chivers et al., 2005), it is likely that the rotational traction value may have been higher than this if measured in September.

Figure 7. A section of grass from Camp Nou Camp stadium in Barcelona (2004) indicating thick thatch layer.

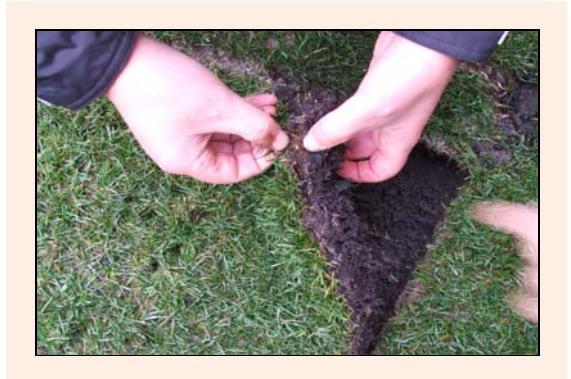
Figure 8. Turf sample from Camp Nou in January 2006 indicating 'join' between the portable squares.
